66726983 WR560 EA SB CAT 3

LINTST, Linton-Stw, Cambridge Road, Linton, Cambridge, CB21 4JD

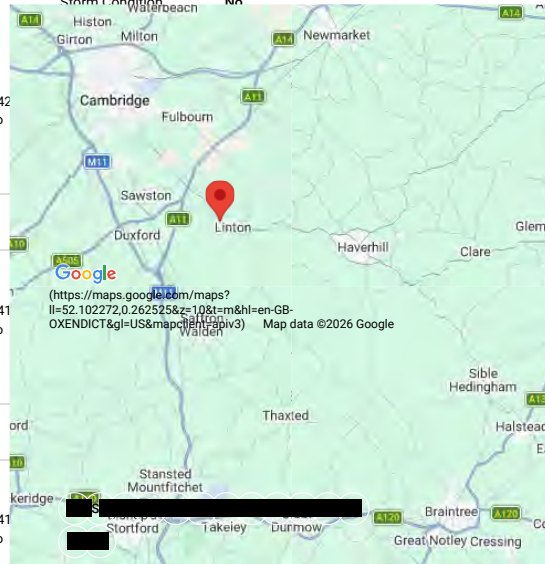
Additional Evidence - Watercourse
 Upstream (100m) - Location: ///barstool.rang.restored
 Sample: Ammonia 0.13 mg/l - Photo DateTime: 17/09/2025 13:31:45
 Sample: Turbidity 5 NTU
 Crystal clear water, light flow, sallow waters.
 No visual impact, no oudure and no wildlife in distress.

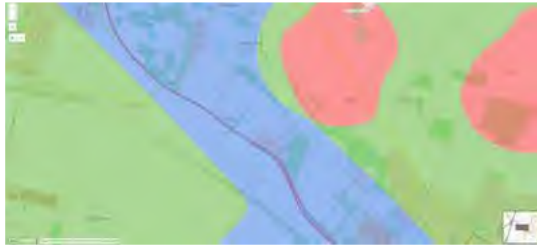
Magic Map shows location is in an SPZ 3 area, there is an SPZ 1 although discharge point is not in this and the river flows away from this.

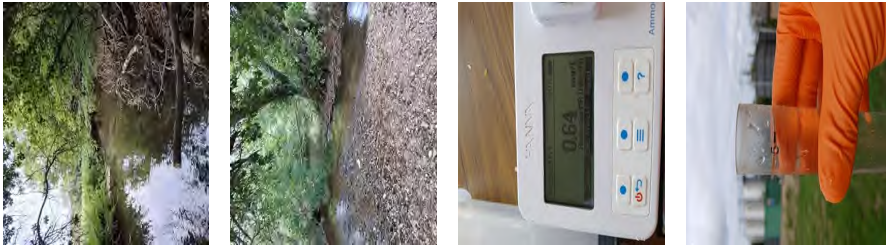
Downstream (100m) - Location: ///will.triathlon.punctuate

Sample: Ammonia 0.64 mg/l - Photo DateTime: 16/09/2025 14:08:51

Sample: Turbidity 5 NTU

Easy access, gap in trees. Watercourse is fast flowing and low in depth, wiering over stones most of the time.

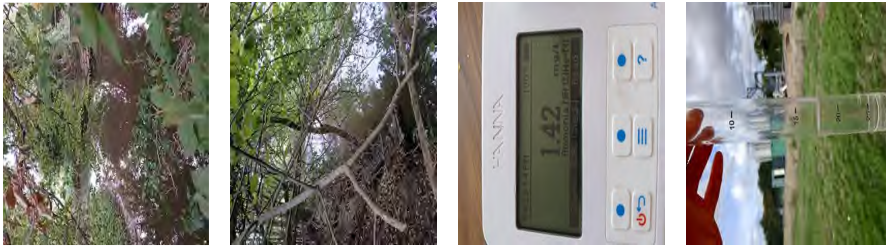
Downstream (10m) - Location: ///someone.sponsors.mainframe

Sample: Ammonia 1.42 mg/l - Photo DateTime: 16/09/2025 13:56:40

Sample: Turbidity 18 NTU

Quite overgrown with vegetation and fallen trees, watercourse quite deep and strong flow pushing further down stream.

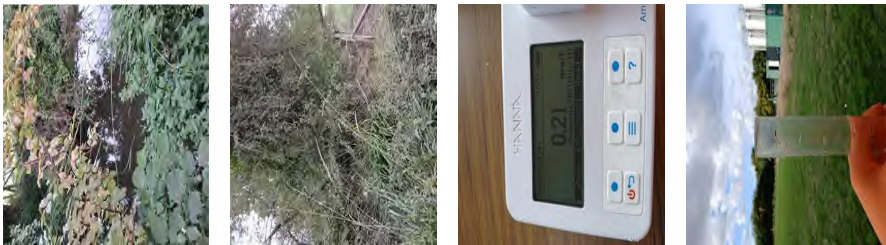
Upstream (10m) - Location: ///youthful.regard.superbly

Sample: Ammonia 0.21 mg/l - Photo DateTime: 16/09/2025 13:41:36

Sample: Turbidity 5 NTU

Quite narrow embankment, a lot of overgrown vegetation. Water course seems to dam itself and has water from further upstream flow into it.

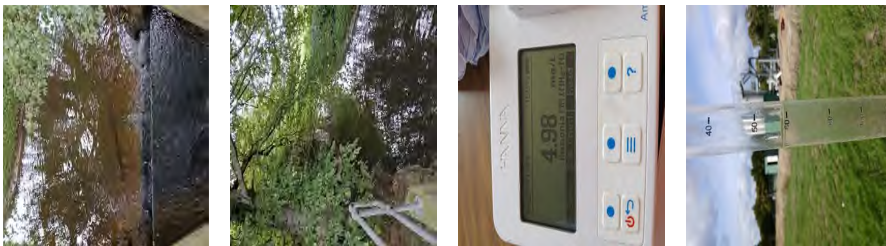
Watercourse Point of Impact - Location: ///served.headset.tilts

Sample: Ammonia 4.98 mg/l - Photo DateTime: 16/09/2025 13:45:42

Sample: Turbidity 60 NTU

Concrete made discharge point, quite deep water and when discharge flow enters watercourse it can be quite turbulent.
