Pollution Report 67671829

The Drift, Harlaxton, Grantham, NG32 1AE

Job Description Investigate Possible Pollution - Triage

HLXDSP, Harlaxton-The Drift Sp, Grantham, NG32 1AE

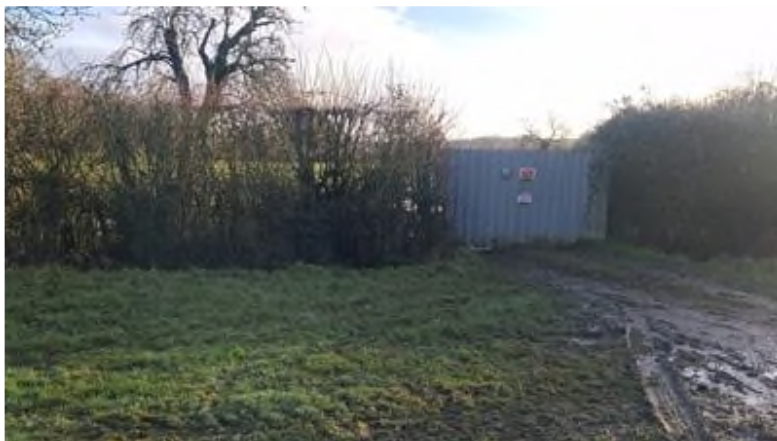
Gate near MH2701- Access to fields - Previously recorded as ///corkscrew.kilowatt.unroll
correct location is ///unity.cassettes.overlooks

Unable to get access to the flooded fields however, it looks like contained rain water.

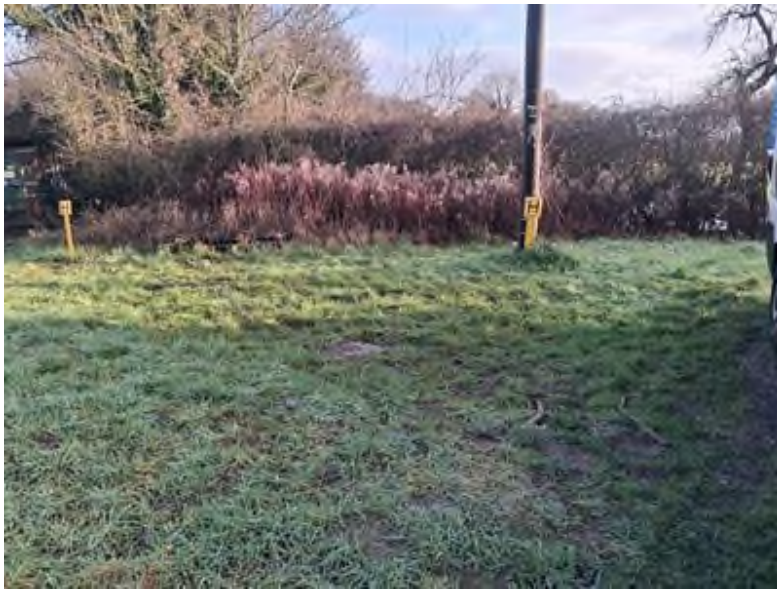
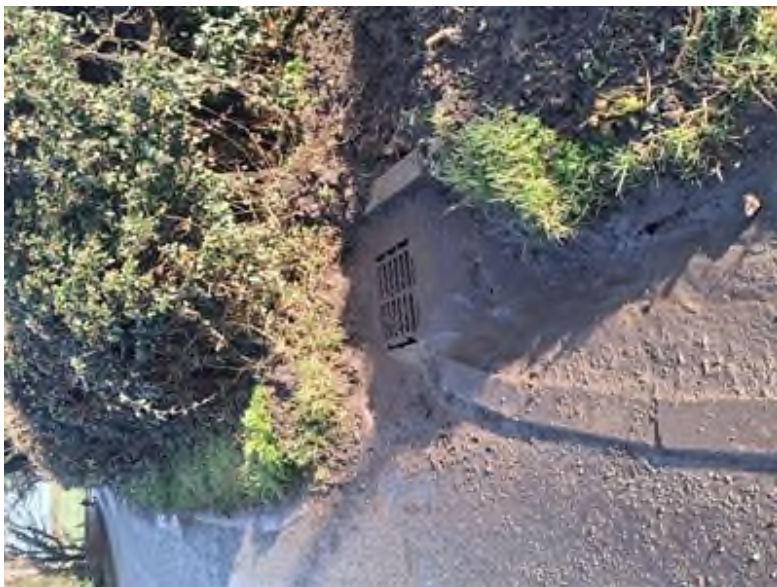
MH2701 & Gully - No more flooding at MH2701

Nothing to sample

No more flooding at the gully either

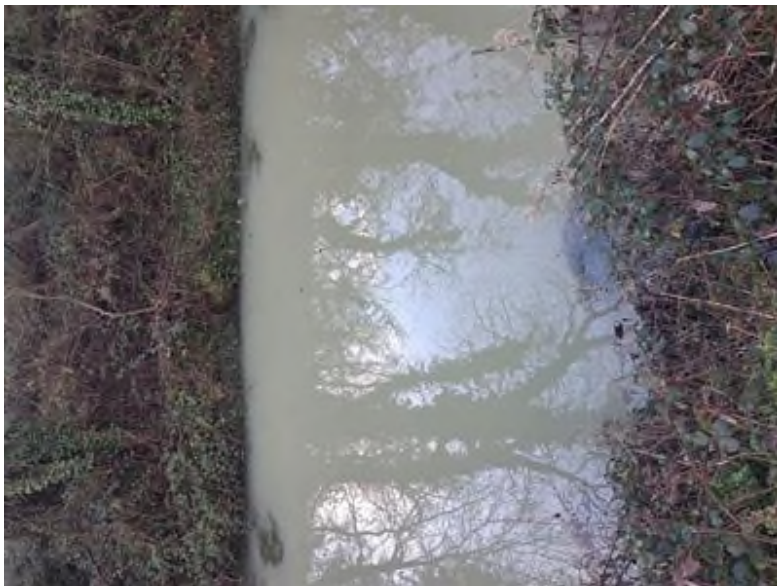
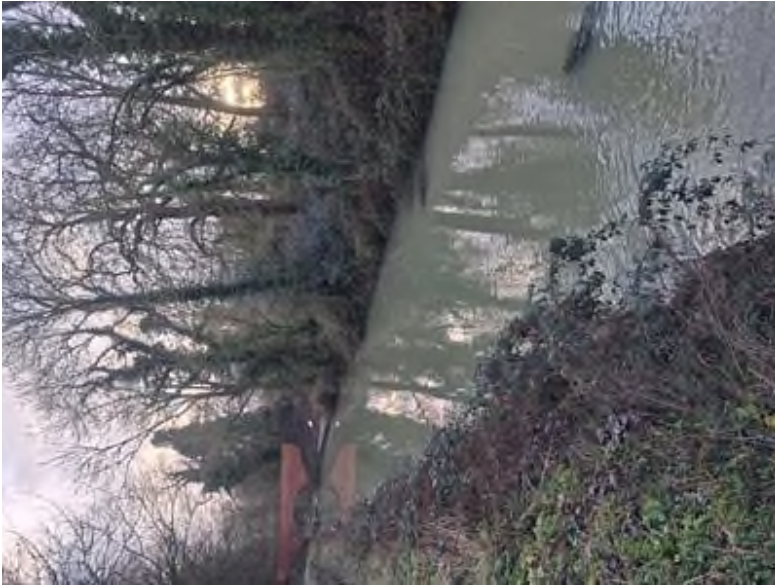
Downstream (80m) - Location: ///tomorrow.empires.deferring

Sample: Ammonia 0.39 mg/l - Photo Date Time: 28/01/2026 08:50:19

No visible presence of sewage or debris from sewage

No signs of wildlife in distress

Visible vegetation floating in water

Water has a good steady flow on it.

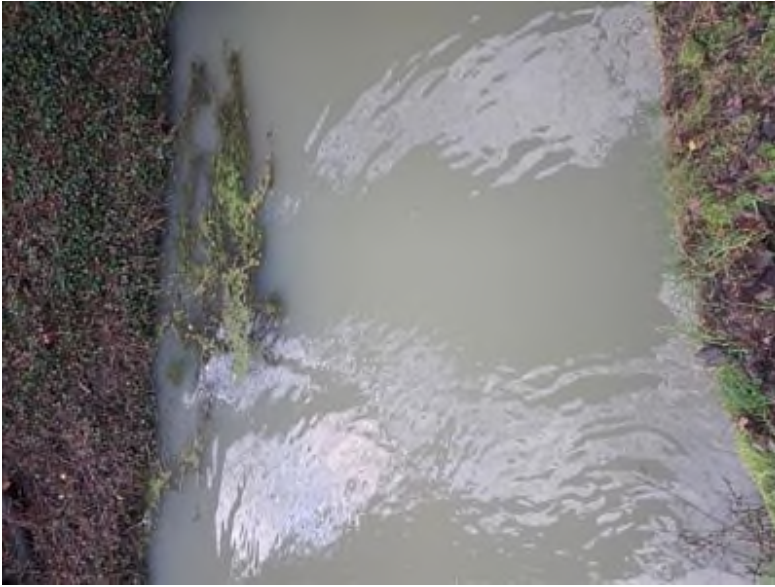
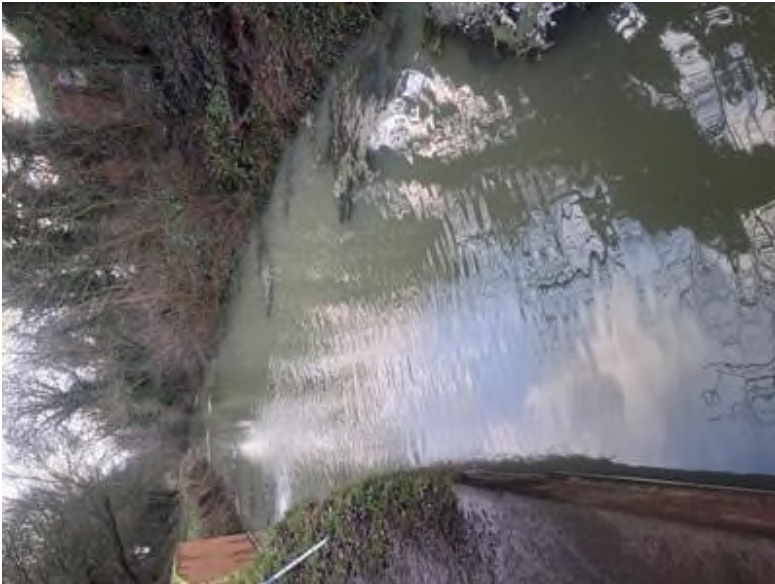
Point of Impact - Location: ///tweeted.punters.diplomas

Sample: Ammonia 0.13 mg/l - Photo Date Time: 28/01/2026 08:37:28

No visible presence of sewage or debris from sewage

No signs of wildlife in distress

Visible vegetation floating in water

Water has a good steady flow on it.

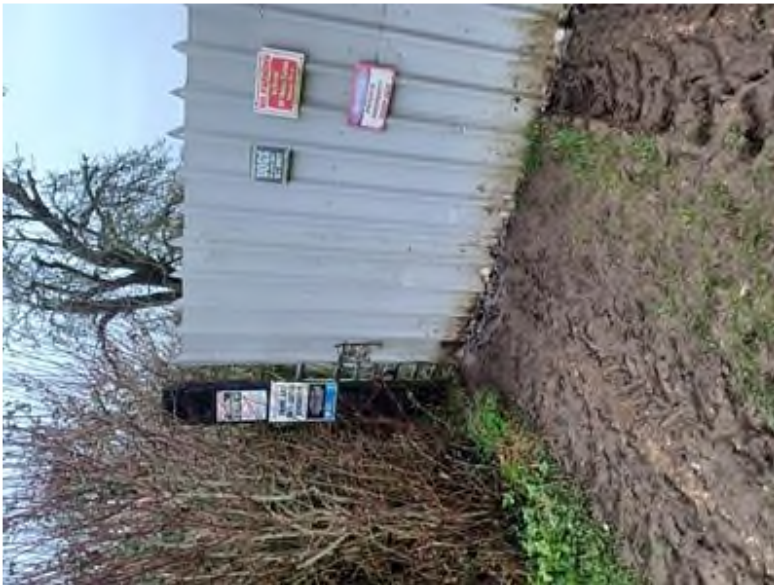
Sample: Ammonia 2.8 ppm - Photo Date Time: 26/01/2026 09:48:18

Gate at mh 2701, unable to access field - Image of locked gate to access flooded area of grass field. Appears contained to this area. Tanker now on site

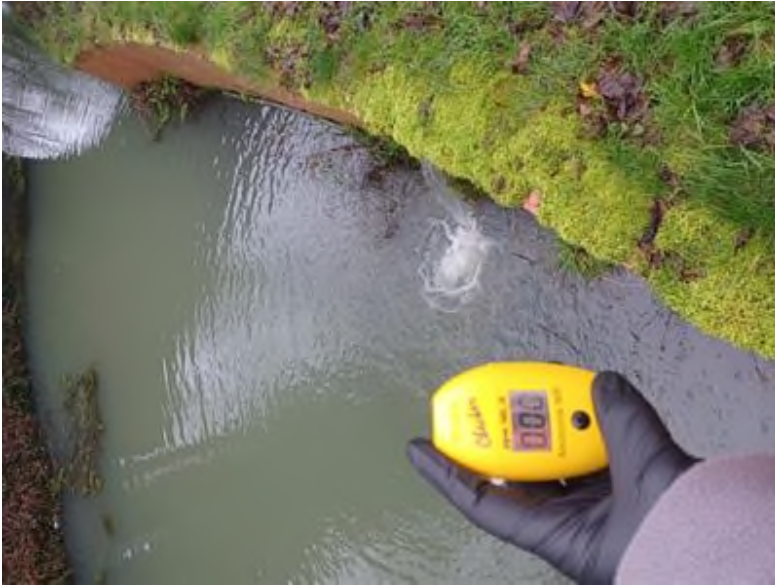
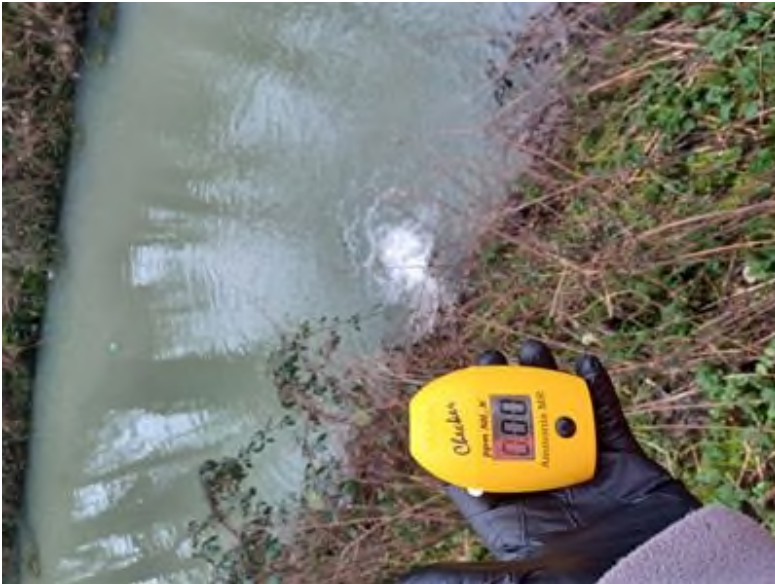
Sample: Ammonia 0 ppm - Photo Date Time: 26/01/2026 10:33:50

Mh2701 - Further sample of a sw outfall at approx helpful.smuggled.bookcases zero ammonia. No other flow found in to canal. From mh2701 the flow has filled a nearby ditch and entered a grass field, locked gate access.

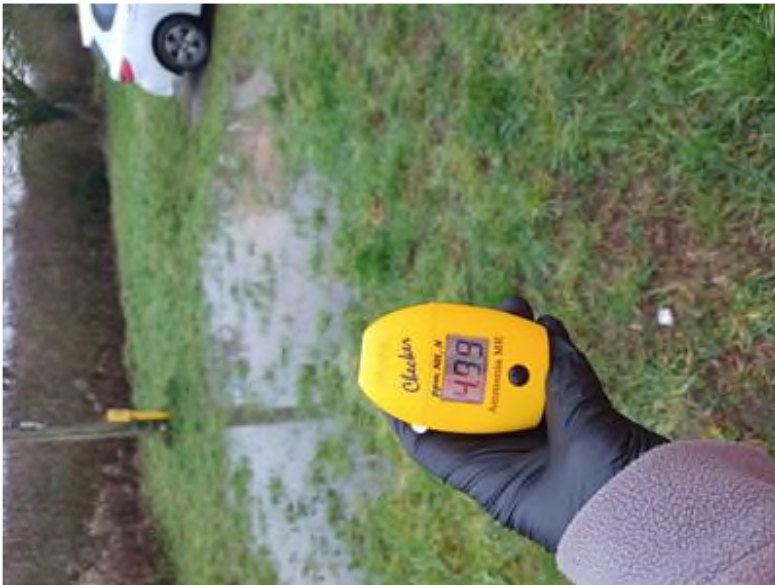
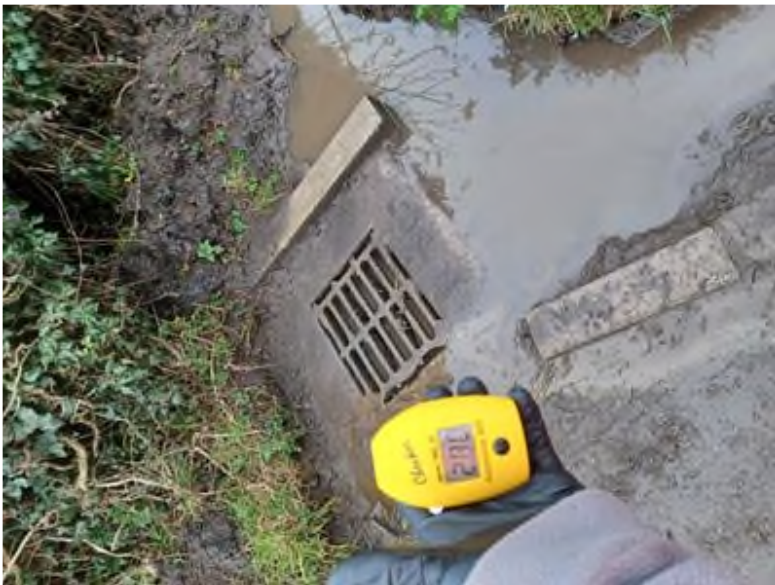
Sample: Ammonia 4.99 ppm - Photo Date Time: 26/01/2026 09:52:45

The drift mh 2701 hydraulic overload - Hydraulic overload , flooding from mh 2701, flooding in to field and ditch line, ditch line 3.1 . Flow to sw drain 2.80

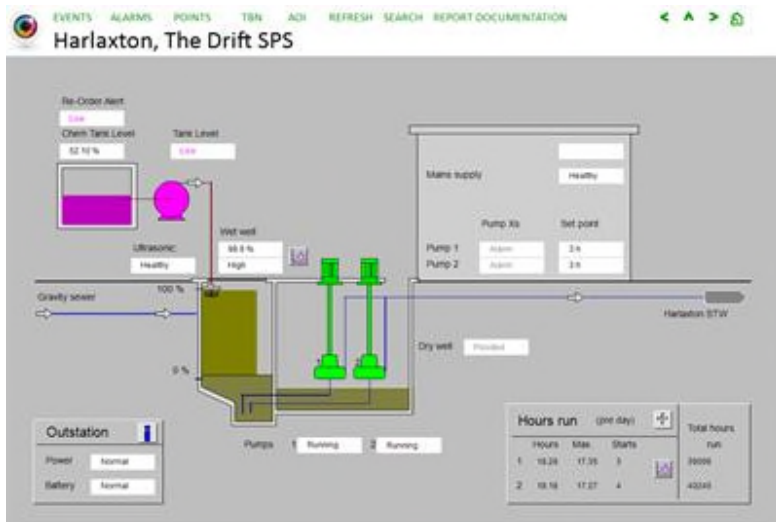
HLXDSP-Iris shows dry well flooded- WW @ 98.9%- this is due to Hydraulic overload of the system due to the rain

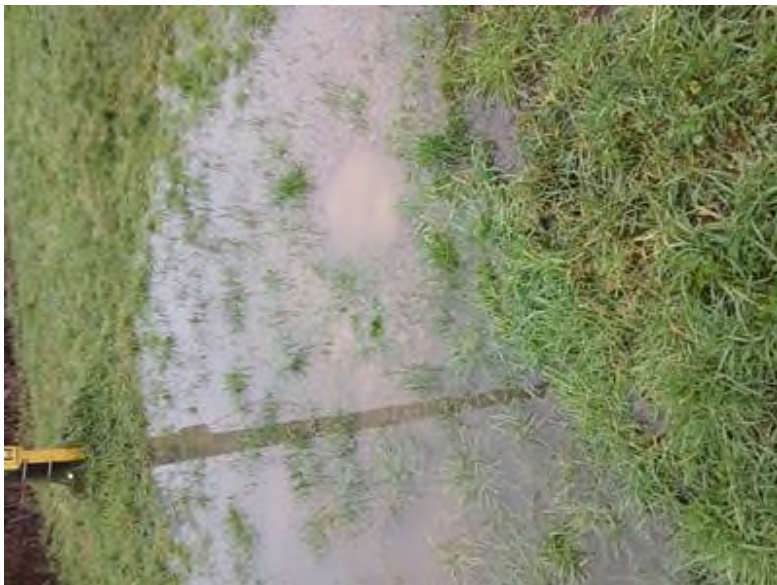
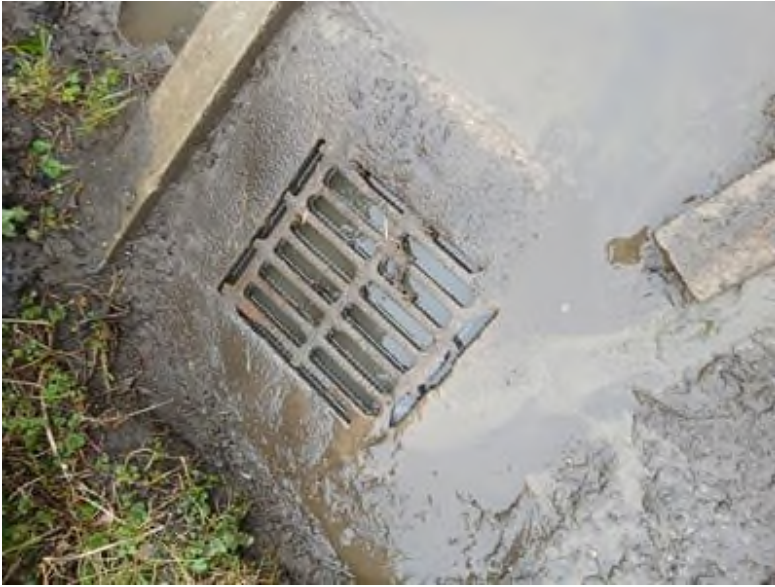
Mh 2701 - M&E was onsite when i got here. He says ps HLXDSP is all full up. He has ordered a tanker on T2. Gully that flooding is going towards looks blocked and going to dry ditch right next to entrance of ps.

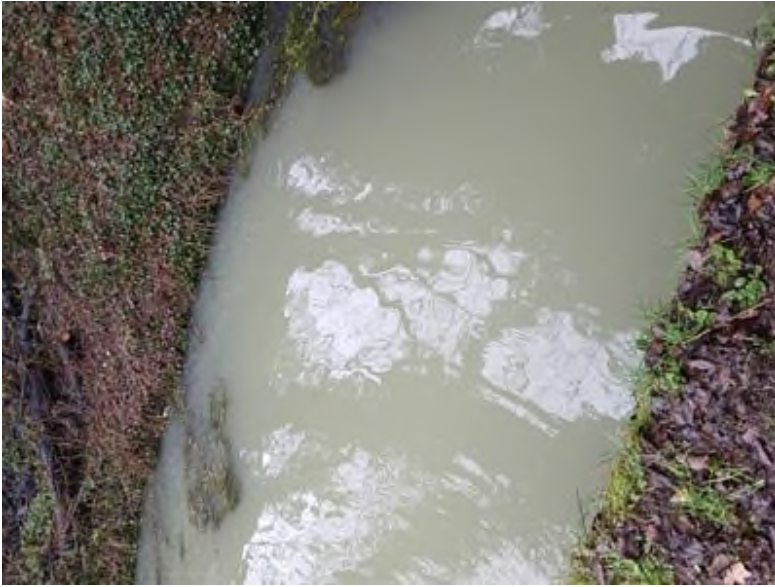
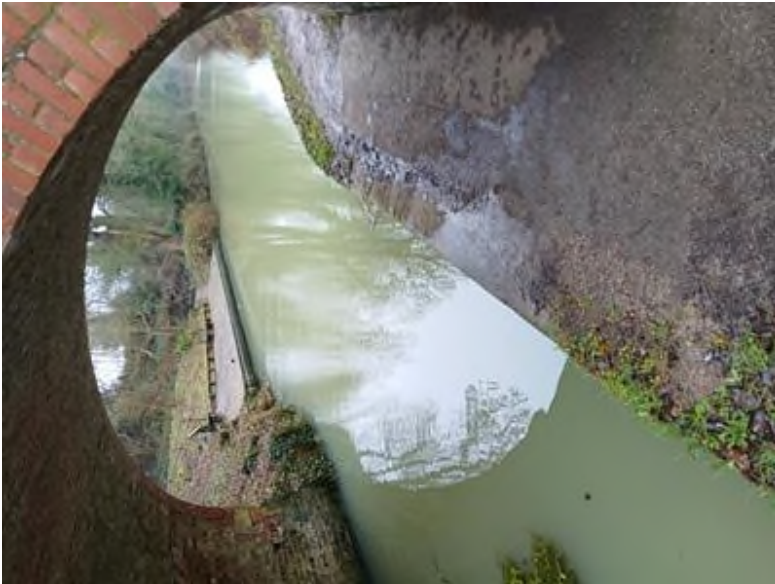
Point of Impact - Location: [tweeted.punters.diplomas](#)

Sample: Ammonia 0.87 ppm - Photo Date Time: 25/01/2026 12:05:16

No mapped sw, not too sure where outfall is so took sample to closes point

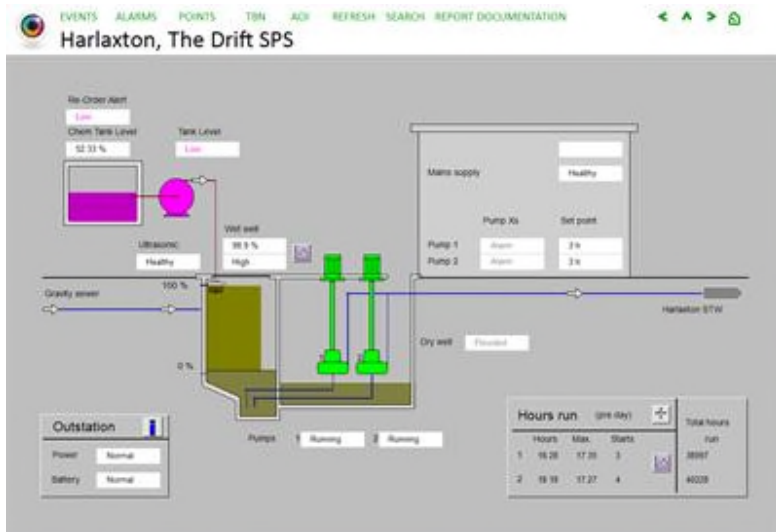
VVX shows WW level high (98%), both pumps running, dry well flooded, no EO on site

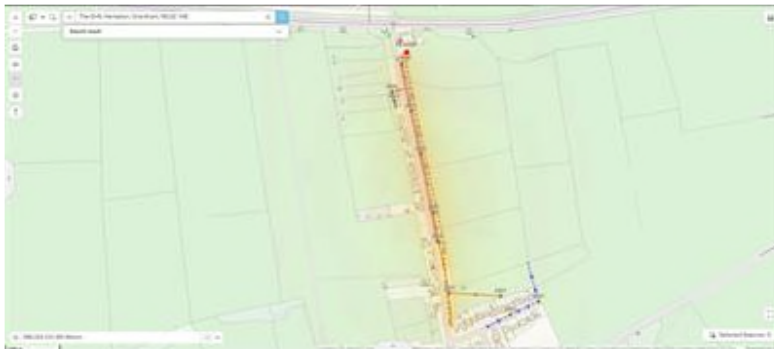
The Hive shows not in any environmentally sensitive areas. Mapping shows one foul gravity sewer entering site HLXDSP, One rising main leaving site and running to HLXTST. No SWS mapped. Canal located 50m from site
