From: [REDACTED]
Sent: 07 November 2022 11:06
To: [REDACTED]
Subject: FW: URGENT REQUEST - DWI Responses

Water Retaining Structure Internal Inspection Form

Regional Supply Area:	East
Supply Manager Area:	Colchester
Site Name:	KEDINGTON HAVERHILL ROAD WW
Site Short Name:	KEHRWW
MTL Information:	SAP No: 2328641. SAP Func: KEHRWW-1F-HYP-TS11-CHT001.
Tank Name:	CT ST1 Tnk1. (WTW side)
Inspection Date (dd/mm/yyyy):	17.03.2020
Date of next inspection (dd/mm/yyyy) - if early check than normal frequency required:	
Inspection Reason:	Final Inspection.
Clean Reason:	New construction 2019 to 2020.
Impact Plan Number:	N/A - New Build.
Inspected By:

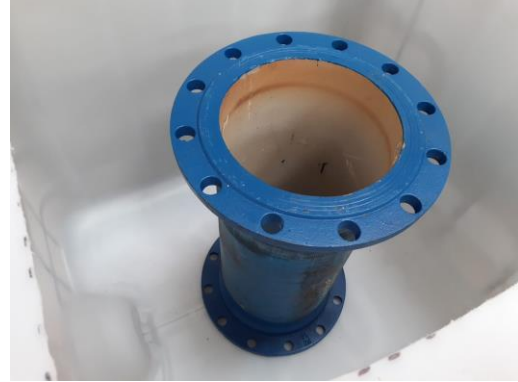
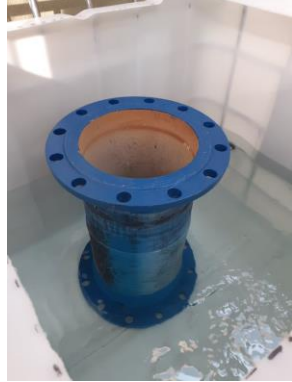
Figure 1 & 2 double flanged ended pipes with 100mm of QD8 coating up the barrel from bottom of pipe standing on the tank floors

Table 2: visual inspection photos for the immersed flange end (QD8 coated region) and the bottom of the tank at the start of the soak test

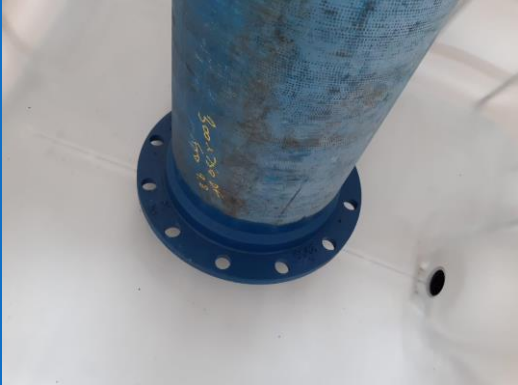
Figure 3 & 4 flanged ends with 100mm of QD8 coating up the barrel from bottom on tank floors

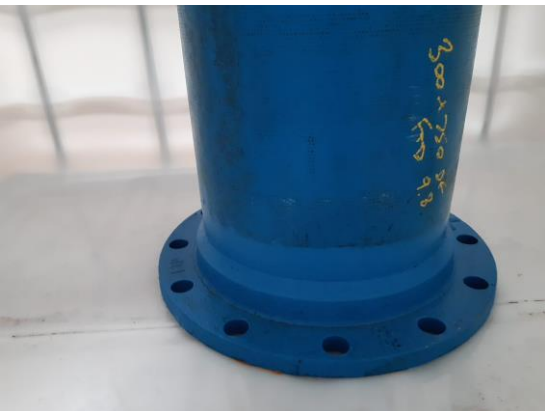
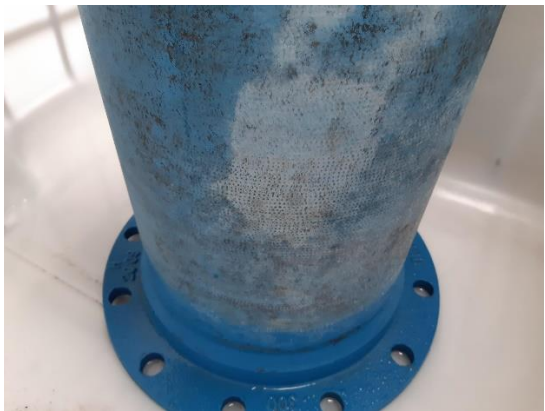
Figure 5 & 6 flanged ends with 100mm of QD8 coating up the barrel from bottom of pipe standing on the tank floors

Table 3: visual inspection photos for the immersed flange end (QD8 coated region) and the bottom of the tank at the end of the 6-week soak test

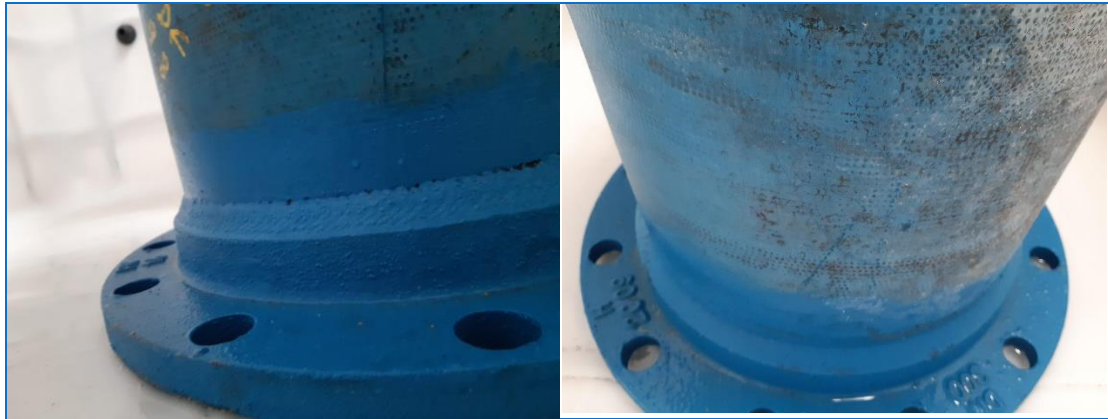
Figure 7 & 8 flanged ends with 100mm of QD8 coating up the barrel from bottom of pipe standing on the tank floors after tanks drained

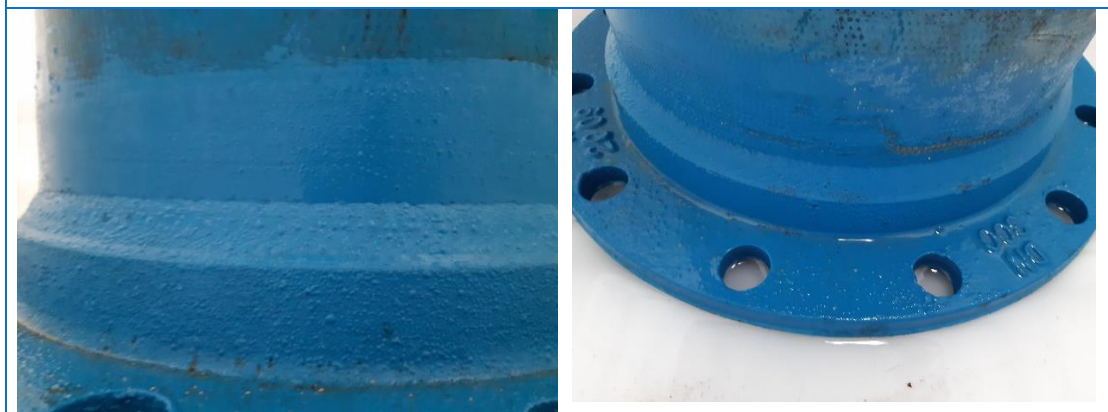
Figure 9 & 10 close up of flanged ends with 100mm of QD8 coating up the barrel from bottom of pipe standing on the tank floors after tanks drained – some rust spots / loose coating visible

In conclusion some minor rusting and flaking of the QD8 coating on both pipes was noticeable at the end of the soak period. The flakes were only noticeable once the tanks were drained and became visible at the bottom of the tank, particularly Tank B (standing water tank).

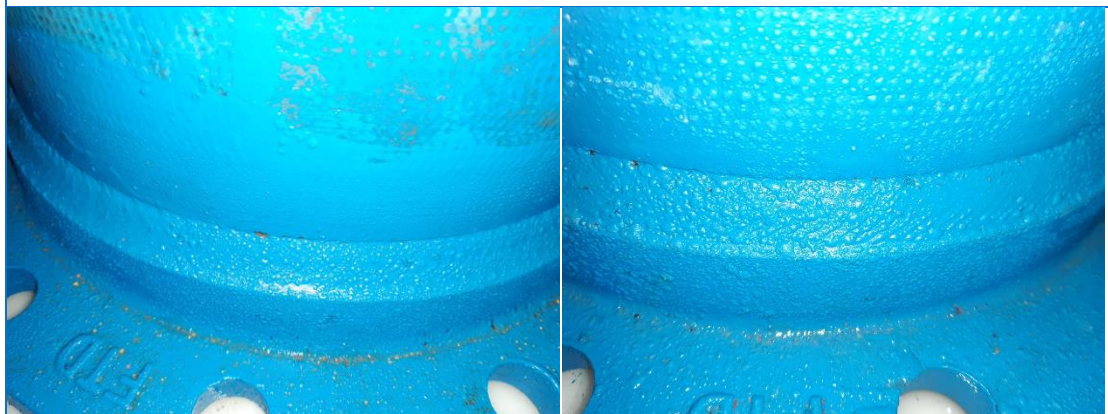
Figure 11 & 12 close up with flash of flanged ends with 100mm of QD8 coating up the barrel from bottom of pipe standing on the tank floors after tanks drained – some rust spots / loose coating visible

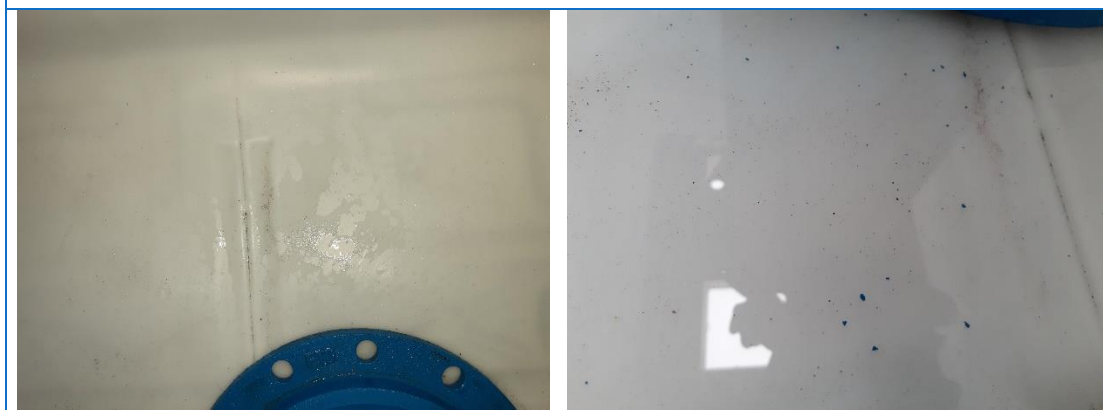
Figure 16 & 17 tank floors looking outside the pipe after tanks drained – some very small flakes of coating visible

Table 4: visual inspection photos of the bottom of the tank at the end of the 6-week soak test
